# Manhole Inspection Summary

Manhole # S59U\_\_006MH

Insp Date: **4/30/08 3:07 PM**

**Location** Address: **1802 S. Newkirk St.**

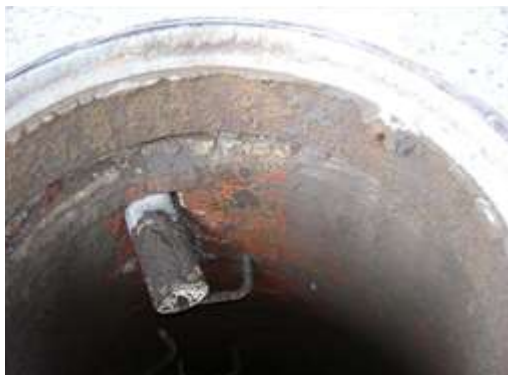
Defect 2

missing mortar under frame

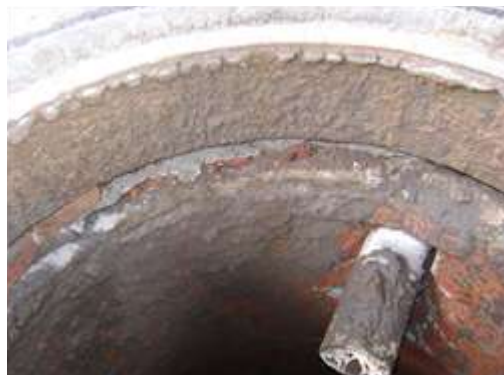
Defect 1

Condition: ☐ Sound ☐ Cracked ☐ Root Intrusion ☒ **Loose Brick** ☒ **Deteriorated**

Infiltration: ☐ None ☒ **Joint** ☐ Cracks ☒ **Mortar** ☐ Roots ☐ Wall

Infiltration evidence on chimney wall.

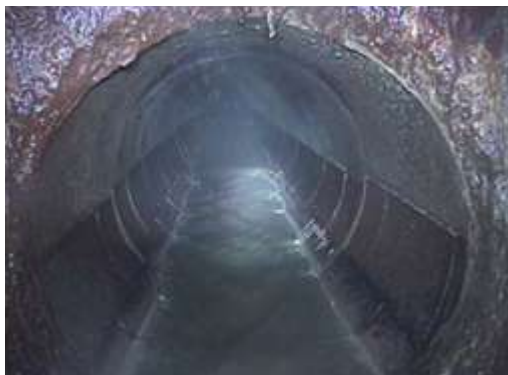
Defect 3

Minerals encrusted on wall above incoming 6 o'clock.

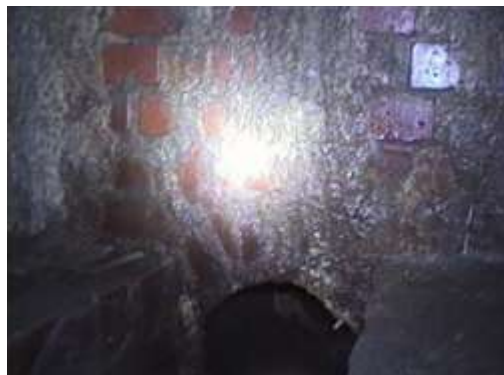
Defect 4

Infiltration: ☐ None ☐ Joint ☐ Cracks ☒ **Mortar** ☐ Roots ☐ Wall

Infiltration evidence on barrel wall.

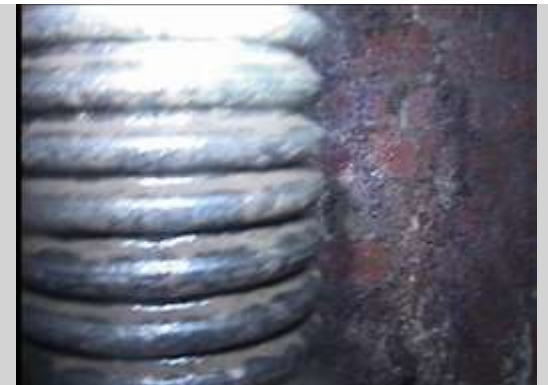
Pipe In @ 2 O'Clock

Comments **NON STANDARD 4" PVC CONNECTIONS ON THE INCOMING 3 O'CLOCK AND INCOMING 2 O'CLOCK CONNECTIONS. THEY MAY BE ILLEGAL STORM DRAIN CONNECTIONS.**

Flex plastic pipe extends from top of hole to channel. Possible illegal connection

☒ Possible Illicit Connection

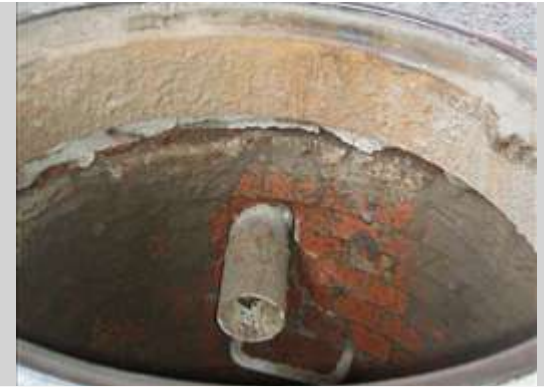
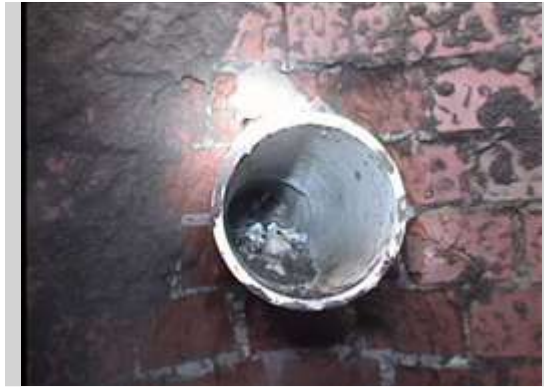
Pipe In @ 3 O'Clock

☒ Possible Illicit Connection

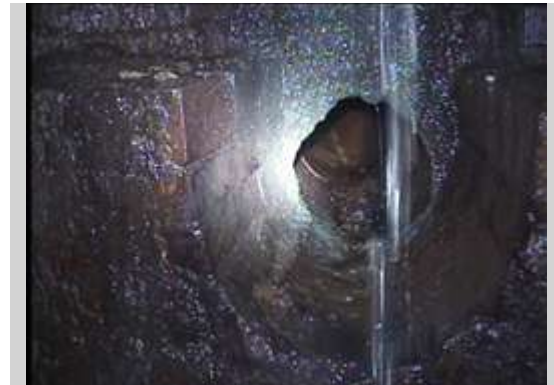
Drop In @ 9 O'Clock

Drop: **Outside** Rod and Bar  
Angled: **Yes** Reading: **21.58** (ft.)  
Inv Depth: **22.58** (ft.)

Drop Condition: **Clogged**
